# 356/912 Resto Strip™

**Split shaft Solex restoration, keep it original!**

**JORIS SCHWEITZER**

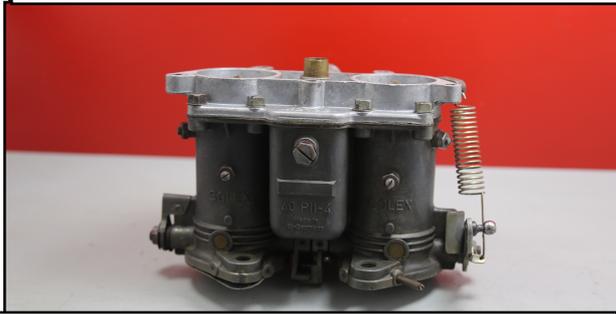
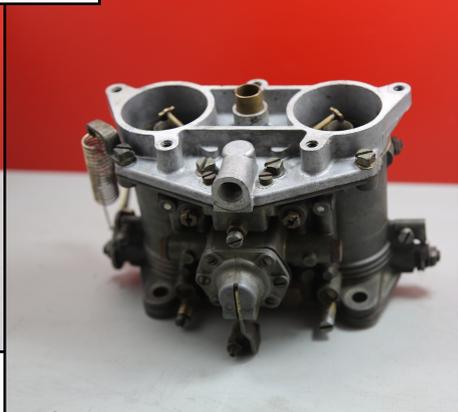
THE SOLEX 40 PII-4 IS A FANTASTIC CARBURETTOR, WHEN IT WORKS... THE SOLEXES ON OUR 356'S AND 912'S HAVE SEEN A LOT OF WEAR AND TEAR OVER THE YEARS. THE BUTTERFLIES HAVE EATEN THEIR WAY INTO THE THROTTLE BORES BECAUSE OF EXCESSIVE PLAY ON THE THROTTLE SHAFTS. TIGHTENING DOWN THE CARB ON THE INTAKE MANIFOLD HAS CAUSED WARPAGE OF THE BORES. YOU CAN TURN THOSE ADJUSTMENT SCREWS ANYWAY YOU LIKE, YOU JUST WON'T BE ABLE TO GET A CORRECT IDLE SETTING DUE TO VACUUM LEAKS ALL OVER THE PLACE. "WHO IS SHOOTING AT ME? THAT'S JUST THE GUY WITH SOLEXES DRIVING BEHIND YOU."

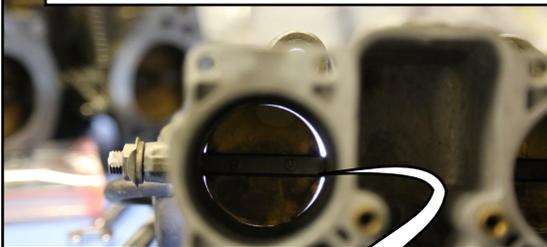
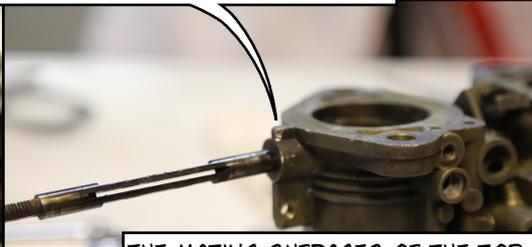
THE STEEL SHAFT THAT ROTATES IN THE SOFTER ALUMINUM THROTTLE BODY DOESN'T JUST CAUSE EXCESSIVE PLAY ON THE PIVOT POINTS BUT IN TURN ALSO CAUSES THE BUTTERFLIES TO RIDE IN THE THROTTLE BORE. THE ONLY SOLUTION IS TO MILL THE BORE TO AN OVERSIZED DIAMETER AND TO FIT OVERSIZED BUTTERFLIES.

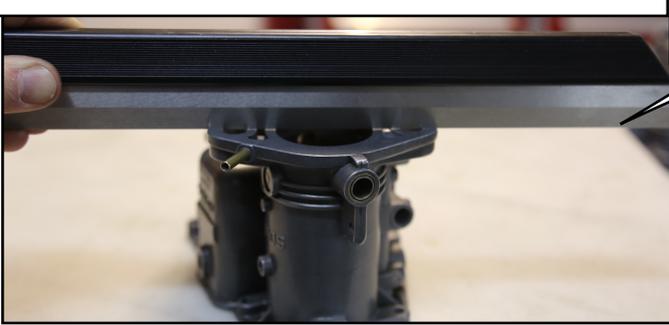
AN EXAMPLE OF AIR LEAKAGE DUE TO WEAR. THESE BUTTERFLIES ARE IN THE FULLY CLOSED POSITION!

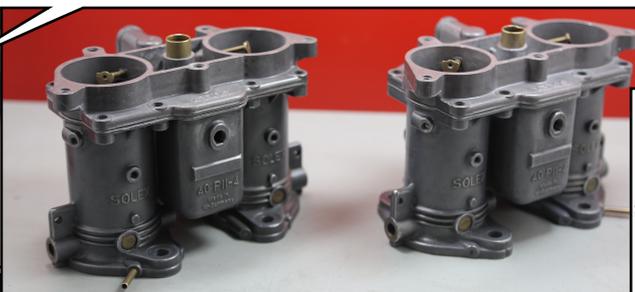
THE MATING SURFACES OF THE TOP OF THE CARB AND THE FLANGES THAT CONNECT TO THE INTAKE MANIFOLD ARE PRONE TO WARPAGE WHEN LOOSENING AND TIGHTENING. THE DIFFERENCE BETWEEN THE LOWEST POINT OF THE FLANGE AND THE HIGHEST POINT WAS ALMOST 0,5MM. THESE SURFACES WILL BE MADE FLAT AGAIN TO ENSURE FUEL AND AIR LEAKAGE DOES NOT OCCUR.

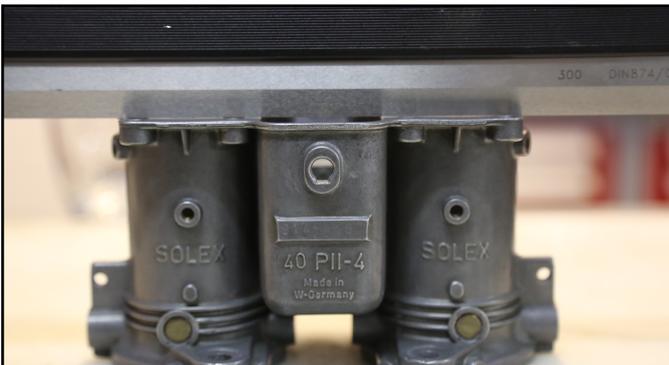
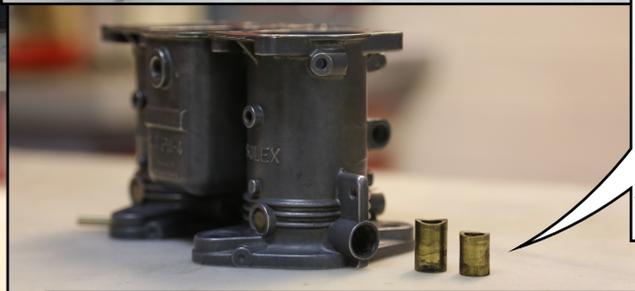
THE PREVIOUS MECHANIC HAD ALREADY INSTALLED BRONZE BUSHINGS IN THE PIVOT POINTS. SADLY THESE WERE ALSO WORN. NEW BUSHINGS WILL BE MADE ON THE LATHE WITH A CLEARANCE OF 0,035MM BETWEEN THE BUSHING AND THE SHAFT FOR "EINEN LEICHTEN SATTENGANG".

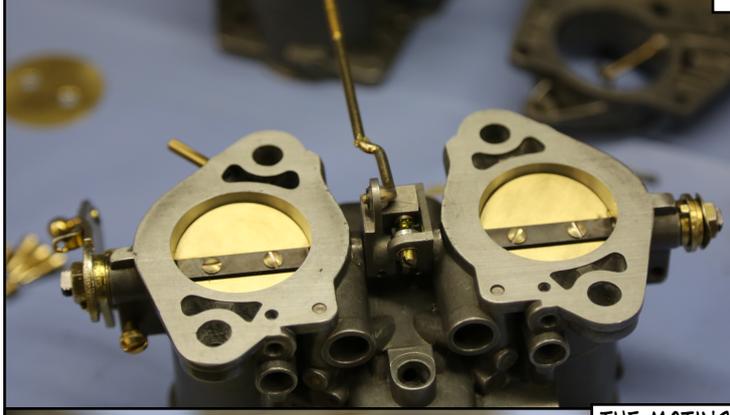
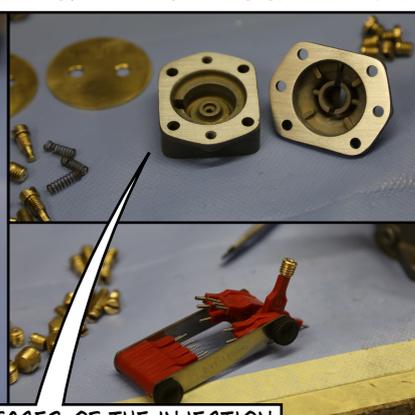
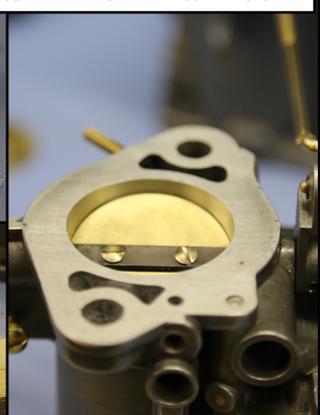
ALL JETS ARE MEASURED AND CLEANED. THE HARDWARE IS REPLACED IN THE ORIGINAL YELLOW ZINC. THE ADJUSTMENT BLOCKS IN BETWEEN THE THROTTLE SHAFTS ARE REPLACED. THESE ARE OFTEN WORN AND BENT. SHIMS ARE USED AT THE ENDS OF THE SHAFTS IN ORDER TO GET THE BUTTERFLY TO ROTATE EXACTLY IN THE MIDDLE OF THE BORE.
