# 356/912 Resto Strip™

**Split shaft Solex restoration, keep it original!**

**JORIS SCHWEITZER**

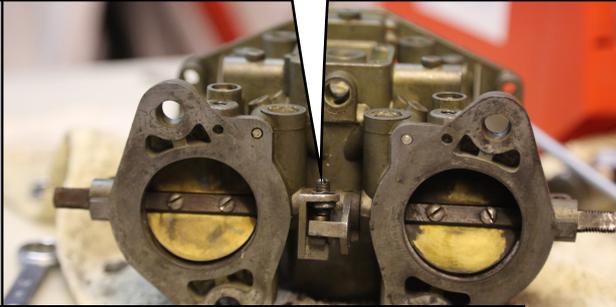
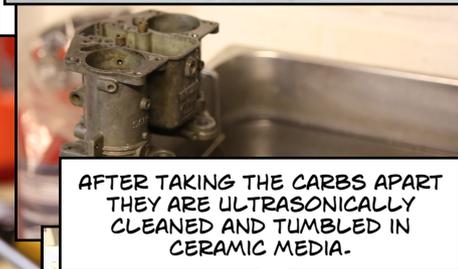
THE SPLIT SHAFT SOLEX USED ON THE LATER 912'S (69') HAD AN ADJUSTMENT BLOCK IN BETWEEN TWO SEPARATE THROTTLE SHAFTS TO BE ABLE TO ADJUST THE BUTTERFLIES INDIVIDUALLY. THIS IS WHAT MAKES TIME TRAVEL POSSIBLE.\*

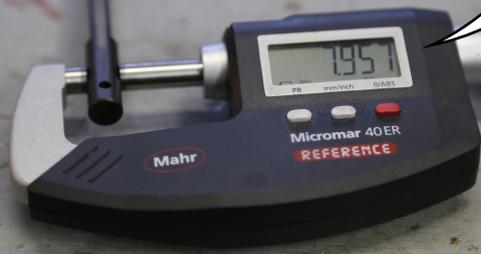
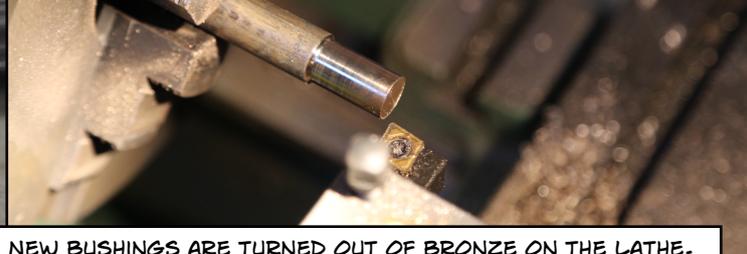
THE NEW SHAFTS I ORDERED HAD A DIAMETER OF 7,957MM. A DIAMETER OF 8MM WOULD HAVE BEEN EASIER TO WORK WITH WHEN MAKING THE BUSHINGS BUT I GUESS I'LL HAVE TO PUT A LITTLE MORE EFFORT IN ON THE LATHE ;)-

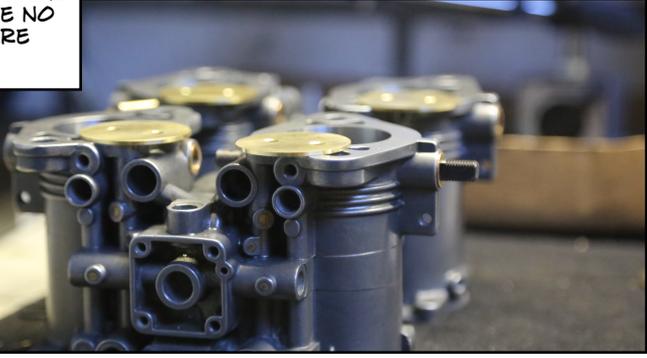
DO YOU SEE ANY LIGHT SHINING PAST THE BUTTERFLY?

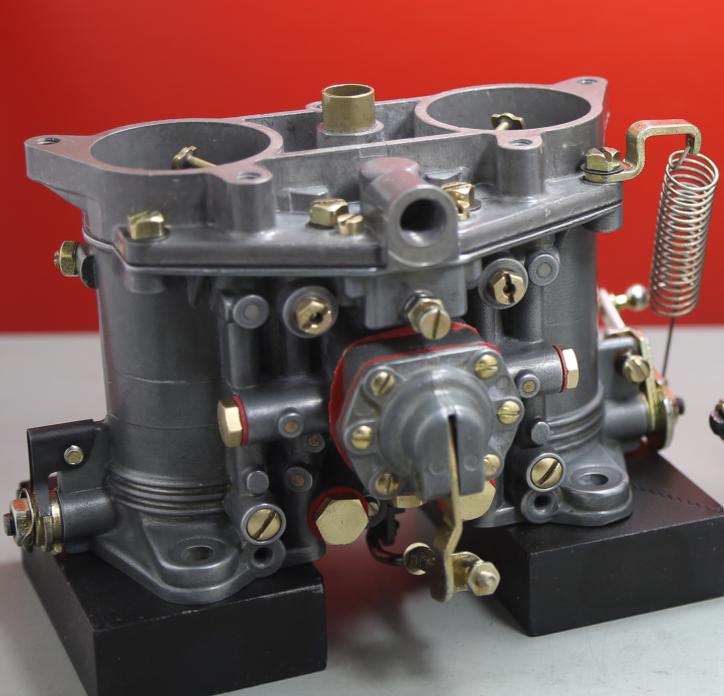
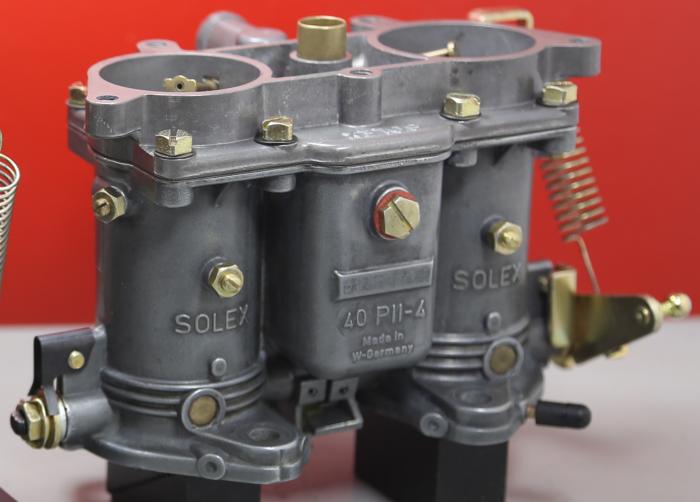
WITH THE USE OF THE IDLE ADJUSTMENT SCREW YOU CAN EITHER OPEN OR CLOSE THE BUTTERFLIES IN ORDER TO ADJUST THE IDLE SPEED OF THE ENGINE. THE BUTTERFLIES SHOULD NEVER BE FULLY CLOSED. THIS WOULD ALLOW THEM TO HIT THE BORES. THIS PHENOMENA WOULD OCCUR IF THE SHAFTS AND BUTTERFLIES WERE WORN. THEY WOULD LEAK SO MUCH AIR THAT YOU WOULDN'T BE ABLE TO ADJUST THE IDLE SPEED CORRECTLY.
